St Peter's, Titchfield, Hampshire

Wriothesley monument 1594

Condition Assessment and Proposal

August 2016

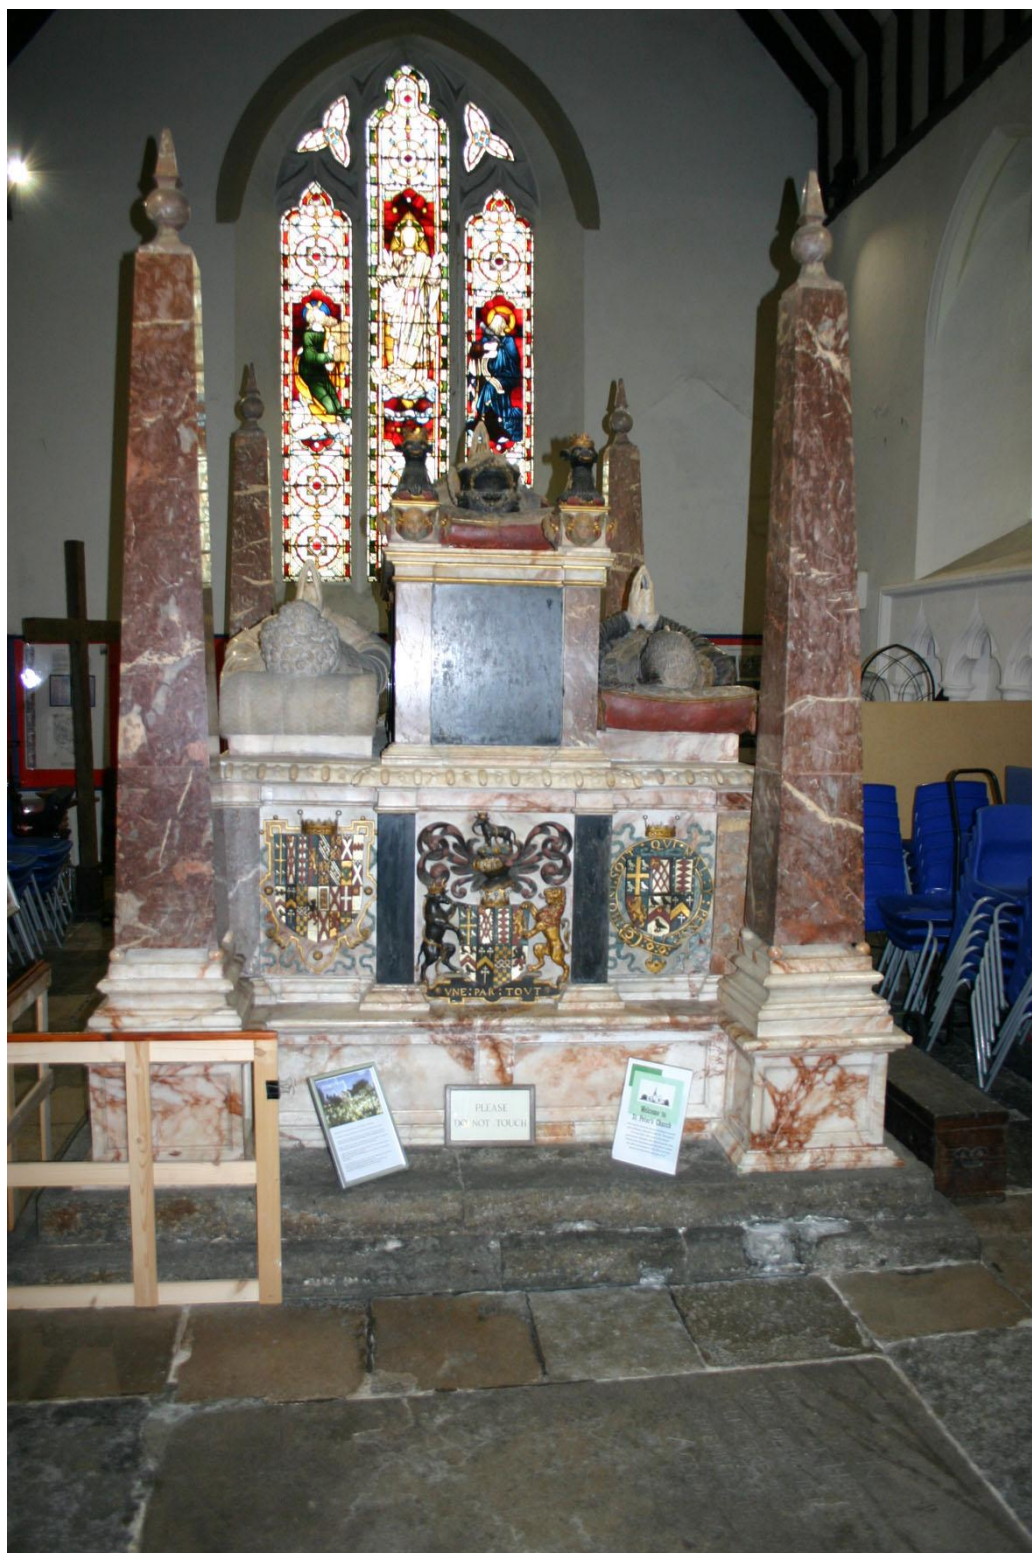
The Wriothsesley monument: general view from west side

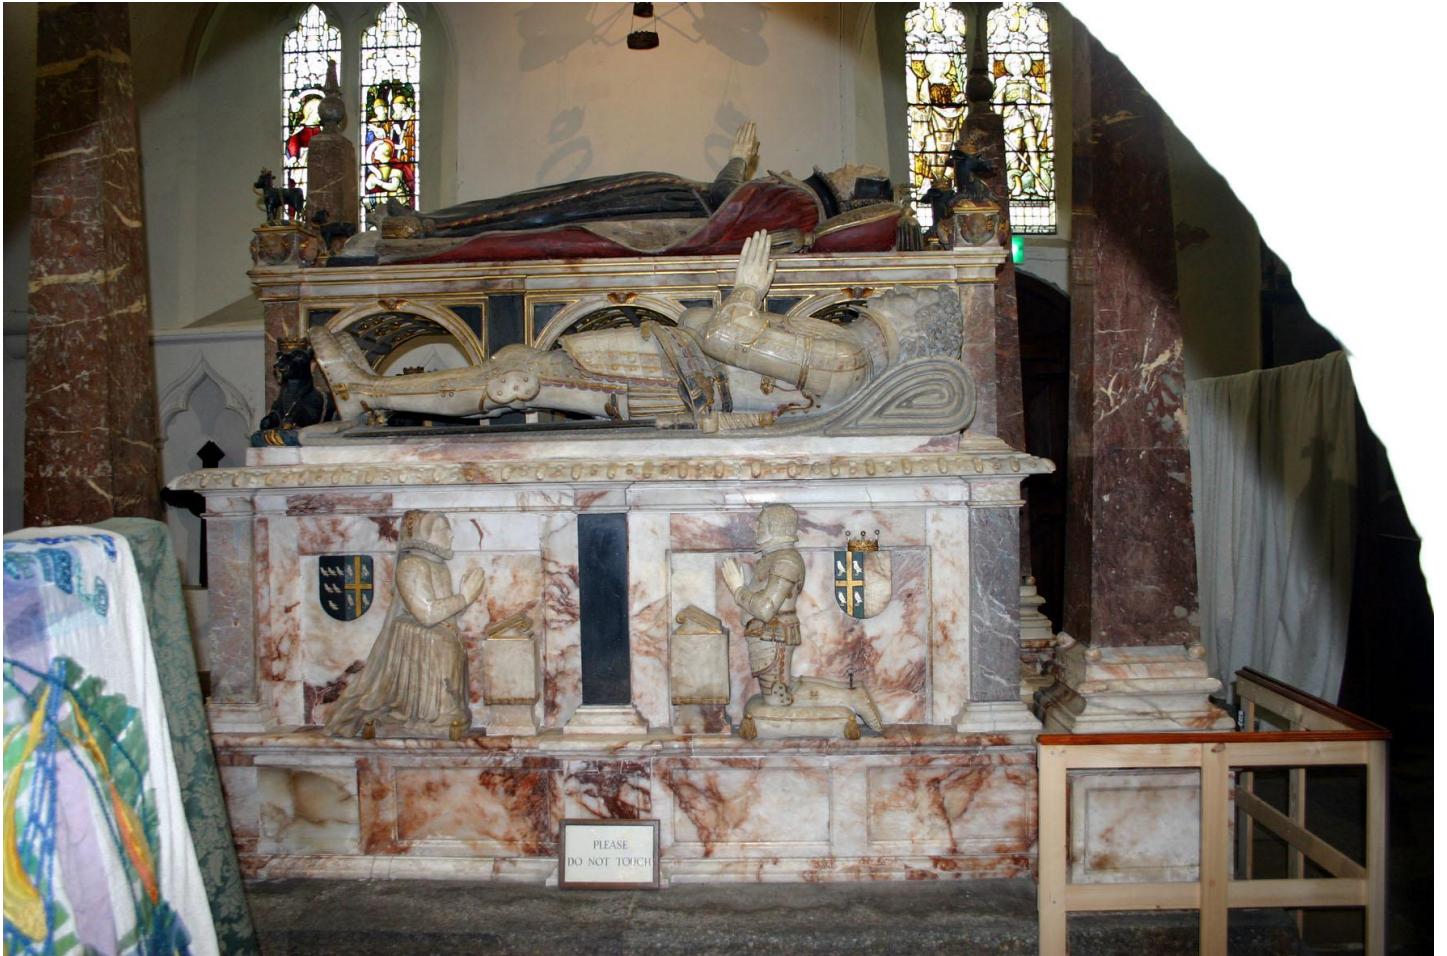
The monument: general view from north side

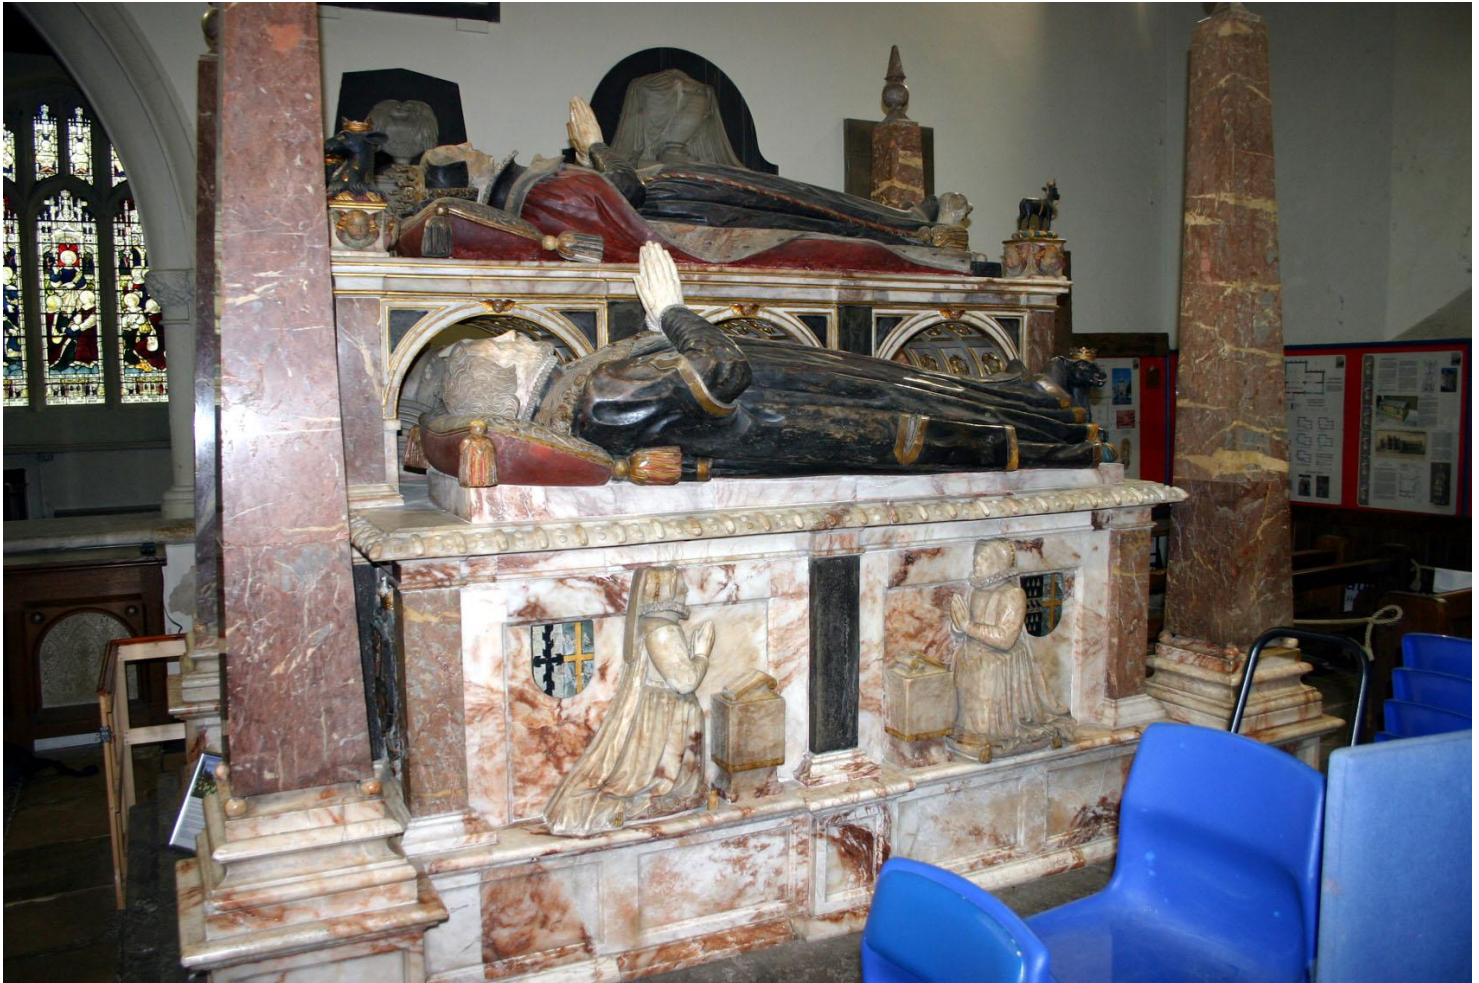
The monument: general view from south side

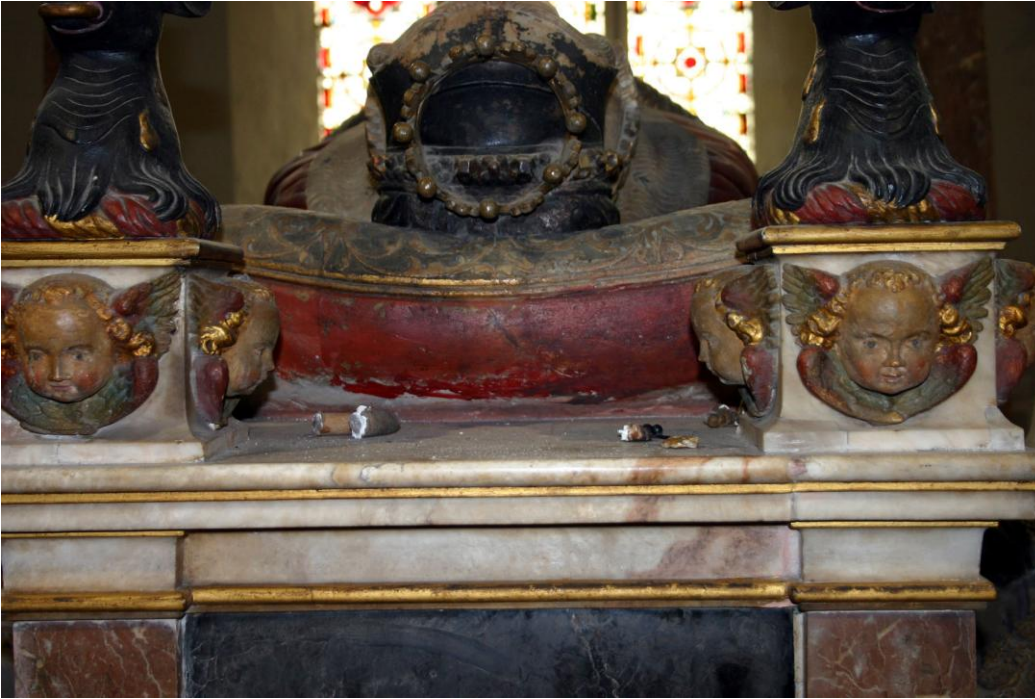
Several small fragments of alabaster are lying by the effigy's head; these appear to be pieces of the small animals at each corner of her bier. The south west animal in particular has lost several small elements and these should be re-fixed.

Fragments of stone lying by the female effigy

- Erect access scaffold to give good access to all areas of the monument.
- Undertake cleaning of all surfaces of the monument with soft brushes and a vacuum cleaner, making a close inspection of all surfaces to ensure that stone and polychrome are sound.
- Re-attach several areas of detached stone, using polyester resin or Paraloid B72 acrylic as appropriate.
- Re-set the south effigy supporting animal and the south side plinth pilaster section after inspecting behind/beneath them in case there are reasons for the current instability.
- Strike scaffold and clear away.

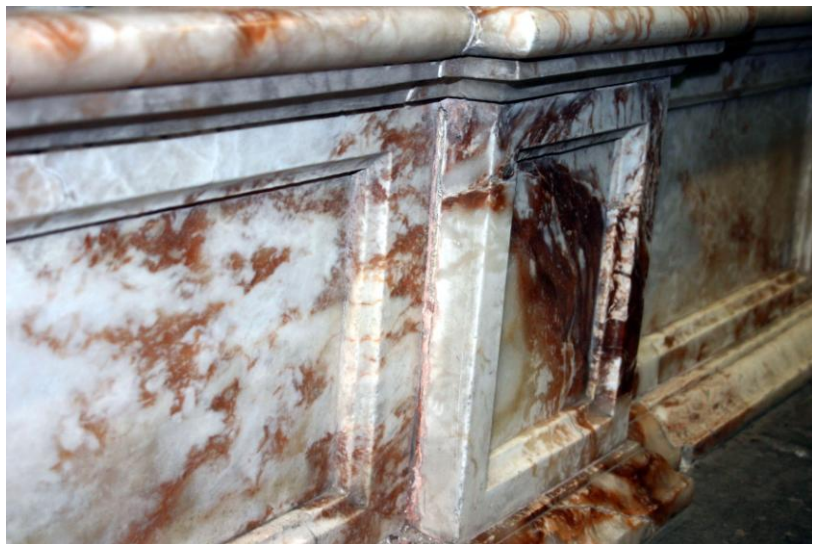
The central projecting panel on the south side is loose and needs re-fixing. Otherwise there are some cracked stones but the damage appears to be old and they are stable.

The loose south side
panel

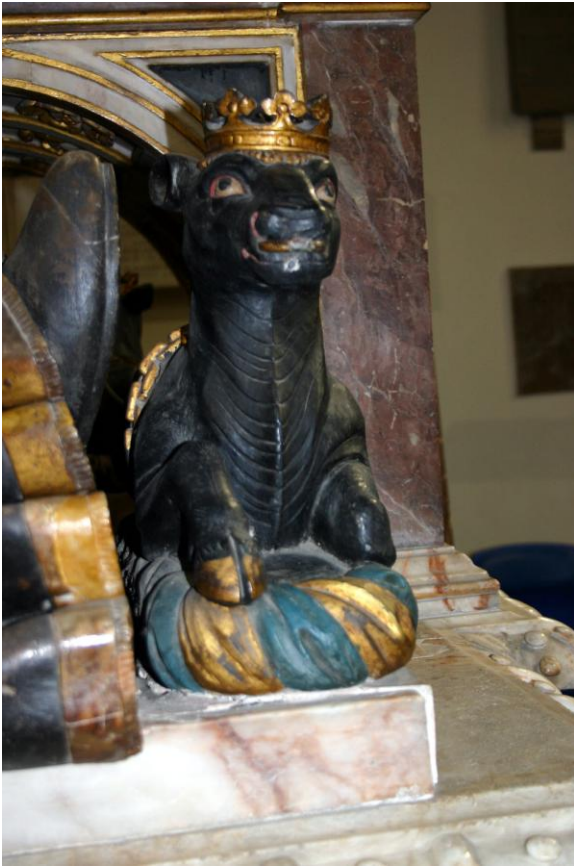
The supporting animal is loose and slightly displaced on its plaster bed. This is not in itself a problem, but should someone manhandle it for some reason it might sustain damage and could be vulnerable to theft. It would be advisable to re-set this animal, and investigate under the plaster bed at the same time to establish if there is some reason for the displacement.

The loose supporting animal

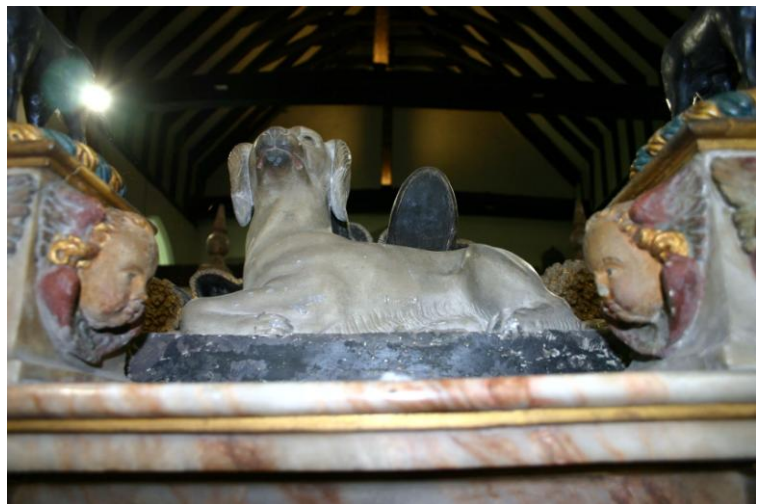
The female effigy itself is stable; there is evidence of renewed polychrome at the base of her supporting animal (brachet) but no problems were identified.

The brachet supporting animal
